# In-construction tests show rapid smoke spread across dwellings

The paper discusses further proof for the use of diagnostic in-construction testing (iCT) developed by the lead author at Cardiff Metropolitan University as a framework of test methodologies for investigating incorrect installation of, missing, inappropriate or defective components within and connected to the building envelope and the fabric of new dwellings in the UK. Without rectification, these defects can affect thermal performance and thus energy efficiency and lead to increased carbon emissions than specified at the design stage. Use of iCT tests in 2014 and 2015 in collaboration with Sustainable Construction Monitoring and Research has identified a potentially far greater problem than reduced thermal performance, which may lead to complete building failure and occupant injury or death. The paper will discuss findings from three case study construction sites where during a multimethod iCT test approach, smoke spread occurred between dwellings and into means of escape in minutes, which should not be before 30 min or 1 h.

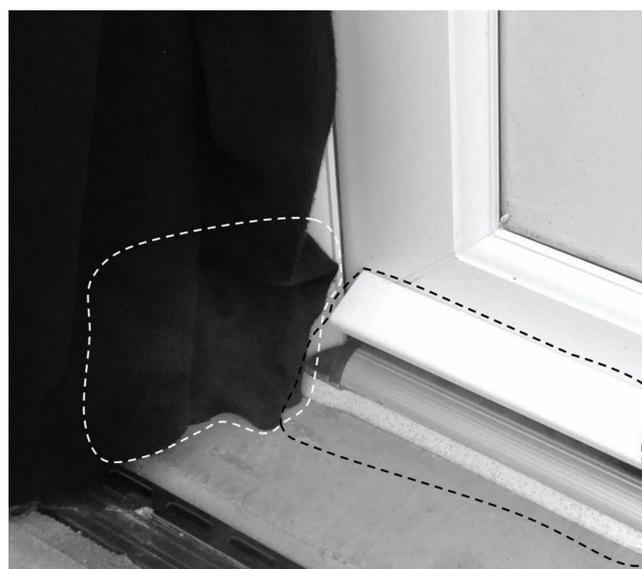
Within minutes, unwanted air leakage pathways were observed externally to the test house with smoke escaping from the eaves level of the roof (front and rear elevations), ground floor trickle vents that were closed in windows. In addition, smoke was seen escaping from underneath window sills and from underneath door frames (see Figures 1 and 2). These air leakage pathways indicated potential failures in product installation, such as exterior doors and windows, and faulty or damaged components such as cavity barriers and seals to exterior doors and windows.

**Figure 1.** Smoke escaping from non-designed air leakage pathways around and underneath one of the exterior door frames in the test flat at case study one during combined air permeability and whole-dwelling smoke test

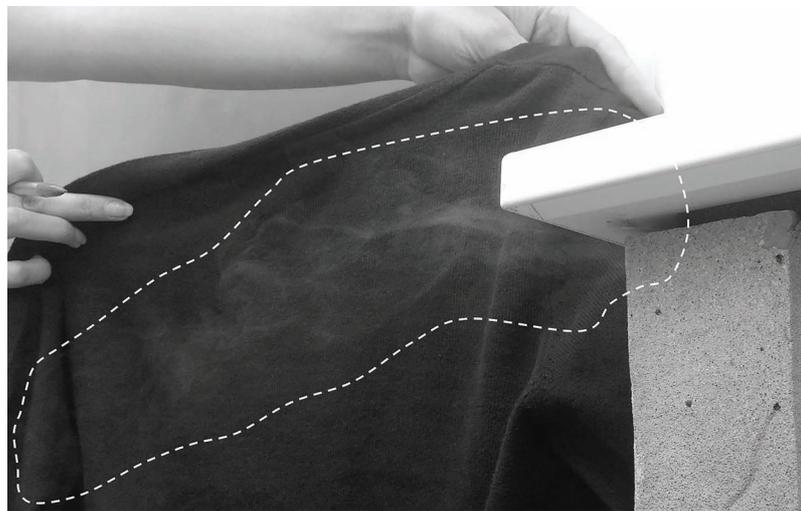
**Figure 2.** Smoke escaping from non-designed air leakage pathways underneath one of the exterior window frames in the test flat at case study one during combined air permeability and whole-dwelling smoke test

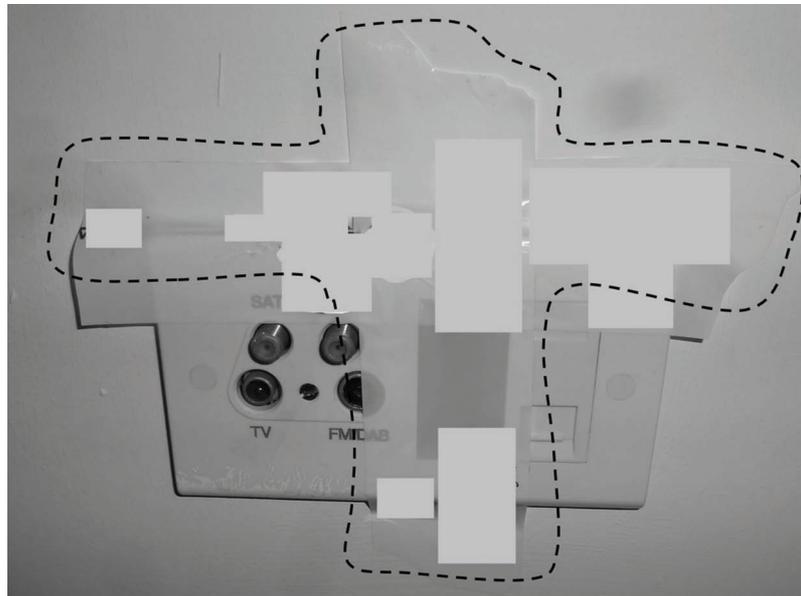
- electrical sockets and ventilation extract ducts in the majority of rooms completely sealed to the walls during tests (see Figure 3 with branding greyed out and Figure 4)
- temporary sealing of holes (some larger than the size of a fist) within the separating walls between flats and means of escape corridor during tests.

**Figure 3.** Observed temporary sealing of electrical socket to an internal partition at case study three test site (not the test flat) not permitted under the air test methodology set out in ATTMA TSL1 (ATTMA, 2010)

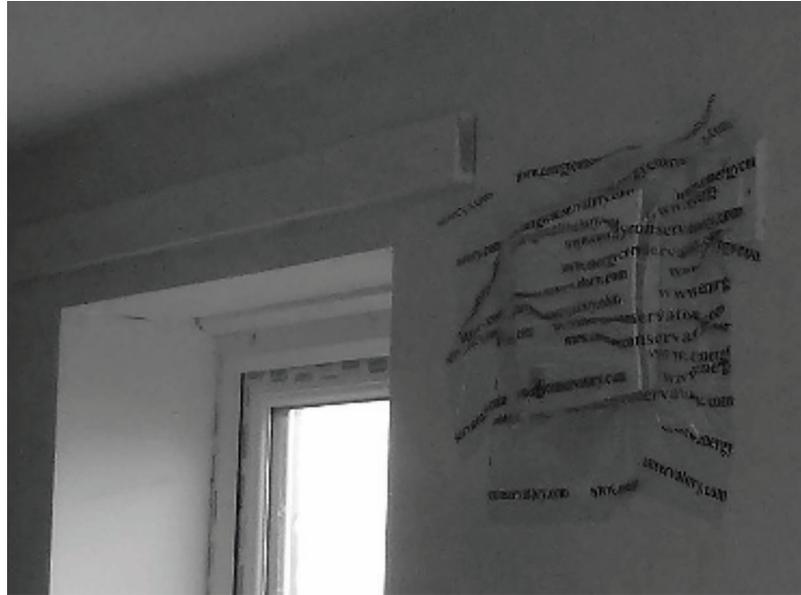
**Figure 4.** Observed temporary sealing around an mechanical extract duct and to an exterior wall at the case study three test site (not the test flat) not permitted under the air test methodology set out in ATTMA TSL1 (ATTMA, 2010)

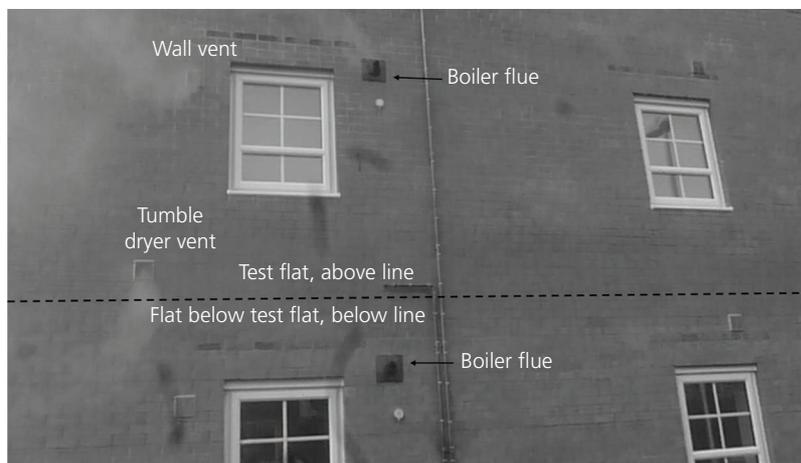
From Figure 5, unwanted air leakage pathways were observed externally from the test flat escaping from the kitchen tumble dryer vent and mechanical ventilation vent installed within the exterior wall, the bathroom mechanical ventilation vent installed in the ceiling and in the exterior wall. The vents (not the boiler) were temporarily sealed in accordance with ATTMA TSL1 2010; thus, the escaping smoke could indicate that the ventilation and boiler vents were not installed correctly through the exterior wall or that they were potentially faulty (see Figure 5). In addition, although the gas boiler was deactivated and is supposed to be a sealed system, smoke was seen escaping from the flue of this boiler and also that of the boiler in the flat below (see Figure 5). Furthermore, in the block of flats where the test flat was located, smoke was present in the roof space (two storeys above the test flat) and seen to be escaping when the loft hatch in the top floor corridor was opened; the meter cupboards on each floor where smoke was seen to be escaping at the ceiling level; the corridors (leading to the corridor window automatically opening) and also

**Figure 5.** Smoke escaping from non-designed air leakage pathways from mechanical and non-mechanical ventilation ducts, the boiler outlet duct in the exterior wall of the test flat and also

the boiler outlet duct in the exterior wall of the flat below the test flat at case study three during a combined air permeability and whole-dwelling smoke test
