CHECKING “FABRIC FIRST” REALLY WORKS: IN-CONSTRUCTION TESTS USING THERMOGRAPHY

Tim Taylor^{*1}, John Counsell¹, Andrew Geens², Steve Gill¹ and Gerraint Oakley³

*1 Cardiff Metropolitan University
Western Avenue
Cardiff CF5 2YB, UK*

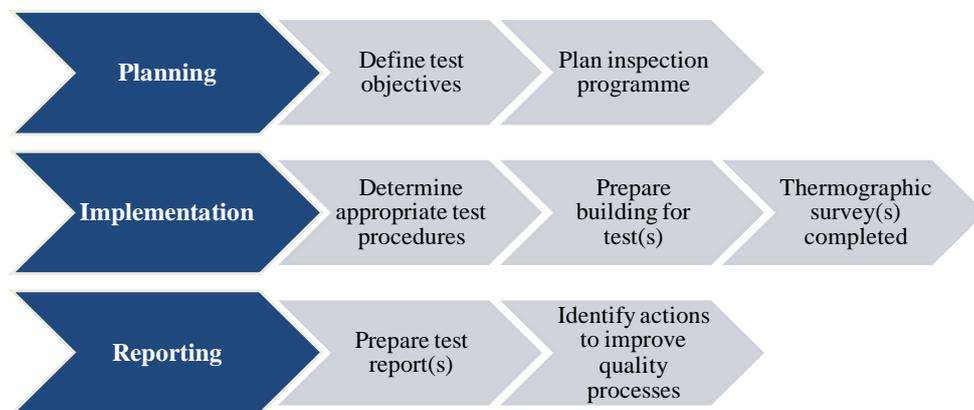
Figure 1. Main elements of the testing approach.

The testing approach follows a process illustrated in Figure 1 comprising three main stages: planning, implementation and reporting. The main purpose of in-construction testing using thermography is to assess the continuity of insulation and identify air leakage paths in the test building. The testing approach is generally consistent with the requirements of BS EN ISO 13187:1998 for simplified testing with an infra-red (IR) camera [10] and is intended to be applicable to all dwelling types. However, practical experience has shown that some specific considerations apply to conducting tests effectively during the construction process and this is reflected in the test procedures outlined in the following sections of the paper. Firstly, it is useful to outline some general principles which help to determine the most appropriate approach to testing:

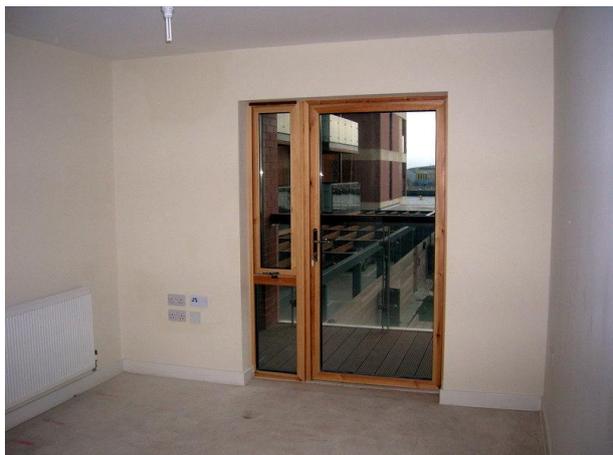
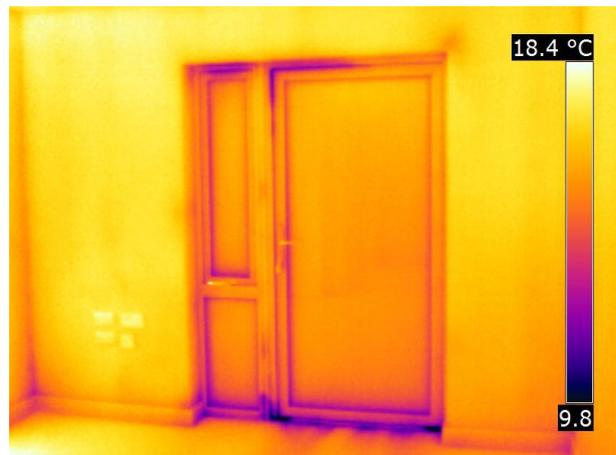
Figure 2. Thermal images of flat in Case Study B.

(a) Photograph taken of balcony doors in living room of test flat at time of thermographic survey

(b) Thermal image of balcony doors corresponding to photograph (a)

The environmental design strategy at Case Study A (a block of 69 flats in timber frame construction) was developed with an assumption that the building would be constructed to high standards of airtightness (achieving an air permeability of $3.0 \text{ m}^3/\text{h.m}^2$ at 50Pa). To determine if this level of performance was likely to be achieved in practice, one of the flats in the development was brought to a more advanced stage of completion so that a pressurisation test could be carried out at an early stage of the construction process. The result of this test showed a measured air permeability of $1.09 \text{ m}^3/\text{h.m}^2$ at 50Pa had been achieved – a significant improvement on the design target. However, masking tape was used extensively to seal around openings and sockets prior to the pressurisation test. The use of temporary seals in this way is not permitted according to the testing protocol that is specified in the Building Regulations: “*All external doors and windows should be closed (but not additionally sealed). This includes door thresholds*” [15]. A thermographic survey of the flat 14 months later showed extensive air leakage around the balcony doors as shown in Figure 2 below.

The masking tape applied around the balcony doors before the pressurisation test effectively concealed these locations of air leakage². On this basis, the pressurisation test result is unrepresentative of actual performance and higher levels of infiltration may mean that the energy performance of the flat is less than predicted. The wind pressures that caused the air leakage observed in Figure 2 can also result in other types of heat loss. In the same flat, a thermographic survey indicated a localised surface temperature decrease in the ceiling of one of the bedrooms. The area of the ceiling where this was observed corresponds with the location of an extract duct for the mechanical ventilation unit. It follows that a possible

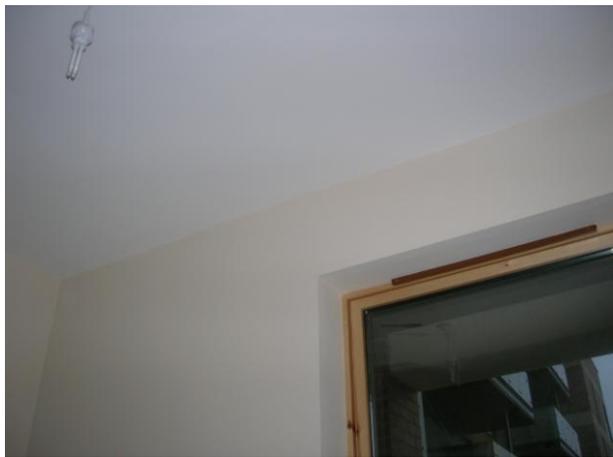
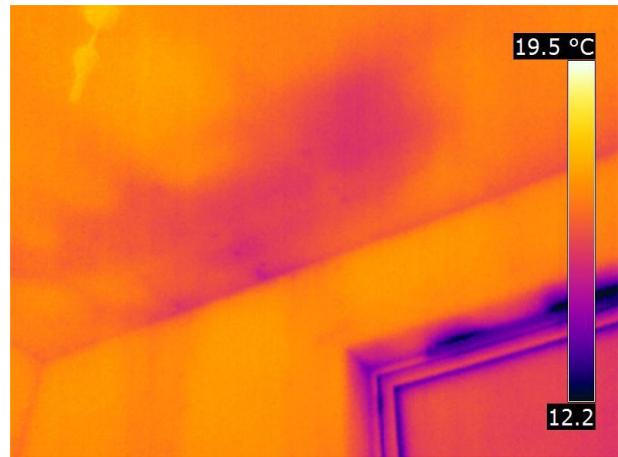
(a) Photograph taken of the junction between the wall and ceiling above a window in one of the bedrooms of the test flat

(b) Thermal image shows localised surface temperature decrease in ceiling area corresponding with the position of the extract duct for the mechanical ventilation unit

Figure 3. Wind cooling effect observed in ceiling below mechanical ventilation extract duct.

explanation of this thermal pattern could be wind penetration above ceiling level around a poorly-sealed or damaged duct air terminal. This type of defect would contribute to heat loss but does not constitute an infiltration mechanism. It would therefore not be detected by a pressurisation test (this is also the case for thermal bypass caused by “wind-washing” [16]).

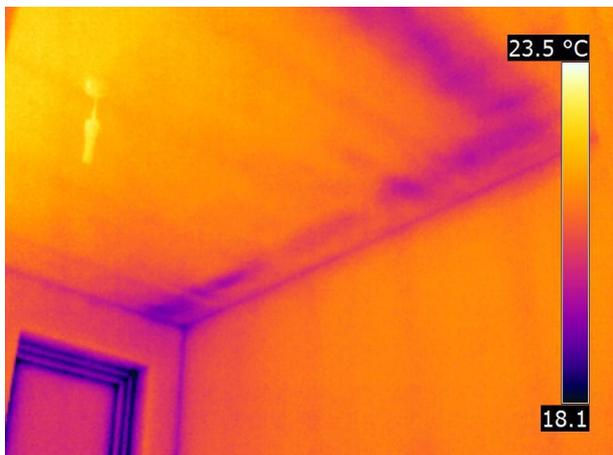
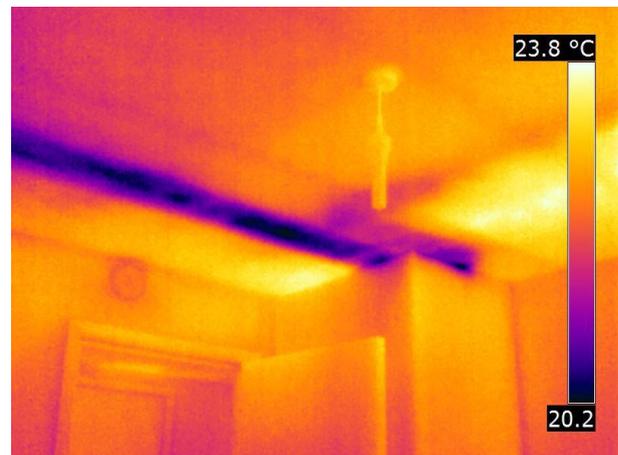
(a) The reduced surface temperatures along the ceiling follow a linear pattern corresponding with the position of the MVHR unit ductwork

(b) The MVHR unit is located in a storage cupboard adjacent to this corner of the room

Figure 4. Insulation not continuous around MVHR ductwork.

At Case Study B (a block of 32 flats, part new build and part refurbishment) the ventilation strategy utilised mechanical ventilation heat recovery (MVHR). A thermographic survey in one of the top floor flats indicated that the inlet duct for the MVHR unit was not correctly insulated as shown in Figure 4 below. Poor installation of the MVHR ductwork will reduce the energy performance of the dwelling.

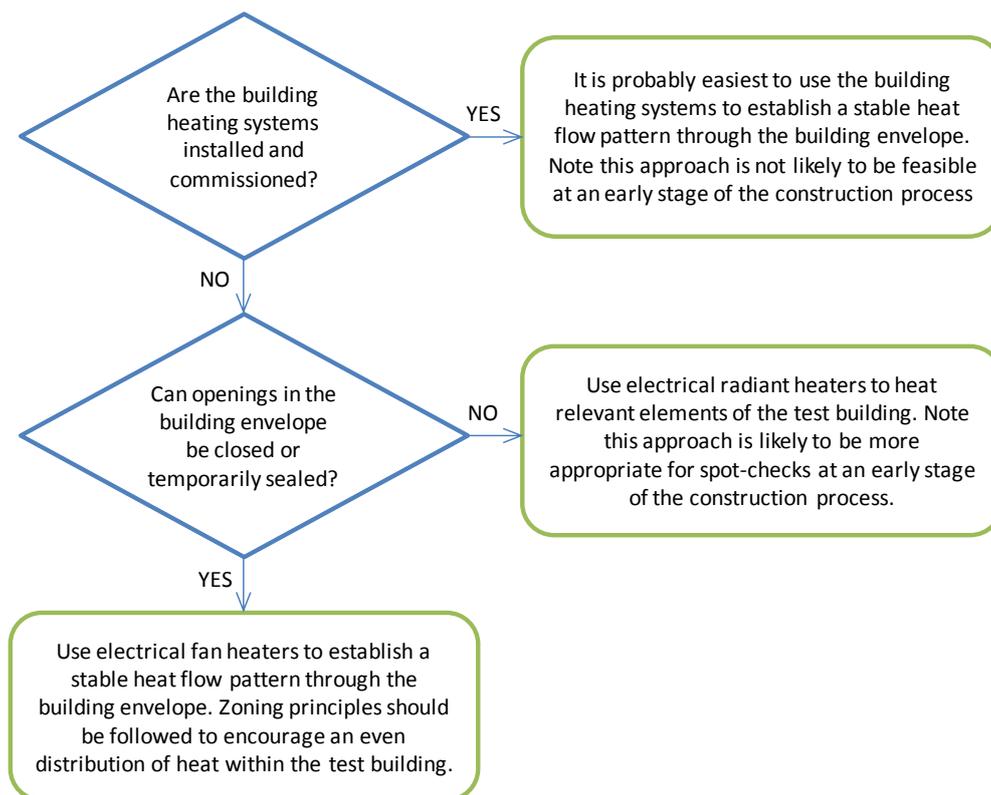
Figure 5. Decision tree for selection of heating method.

1. Select a heating approach using the decision tree in Figure 5.
2. It is preferable to commence heating of the test building at least 24 hours before the inspection. However, a shorter heating period may be adopted if it is not possible to obtain access or permission to operate the heaters outside of normal site working hours. In this case, the number and/or power output of heaters may need to be adjusted to compensate for the reduced heating period.
