7th International Conference on Sustainability in Energy and Buildings

The use of polymer stabilised earth foundations for rammed earth construction

Abstract

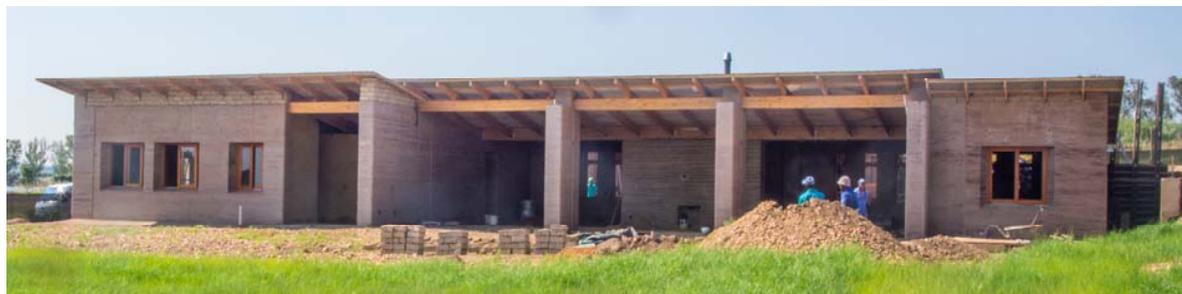
Figure 1 North View of rammed earth house

A rammed earth house was constructed in the north of Johannesburg (Fig. 1) 25° 54' S/ 27° 56' E designed with both a low embodied energy as well as an energy efficient design. The national standards of South Africa require masonry walls to have a R value of 0,35m²K/W and as rammed earth has a value of 0,35 to 0,7m²K/W for a 300mm thick wall [1] it was deemed prudent to exceed this to achieve more than the minimum thermal performance. Walls were to reach a maximum height of 4,2 meters and at a slenderness ratio of 10 [1] would result in a wall of 420mm thickness minimum. Thus, a wall width of 500mm was chosen that exceeded both these specifications. The walls were rammed from soil from the site coloured with natural oxides and stabilised with 4% hydrated lime. The house was roofed with corrugated iron, insulated with 70mm rigid insulation below, with 800mm roof overhangs to provide both summer shading and protect the rammed earth walls.

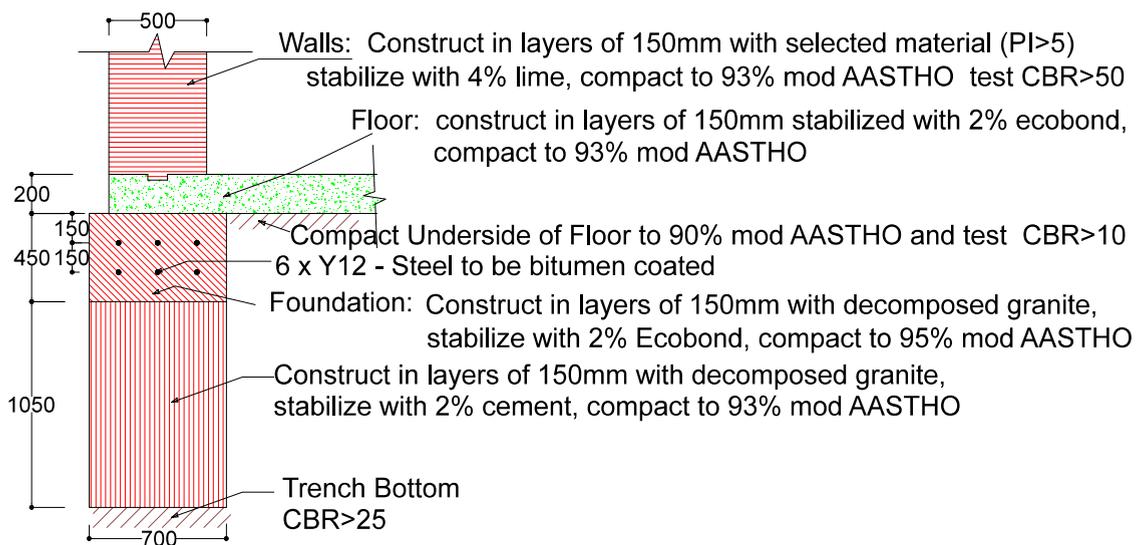
Figure 2 Foundation and wall design by Hans Brink

Polymer stabilised earth is a technology that was developed for road building and as such was designed to be applied at scale with the use of extensive plant [9]. In this case study we were using the product in a house where different methods were required, to road building with far higher number and variety of under floor services, see Figure 2. This section discusses what we did and why and the difficulties we encountered.

The positions of the walls were then marked out on this floor surface and a 100mm wide by 30mm deep groove cut into the floor to create a key for the rammed earth walls (figure2). Formwork was erected directly on the floor slab (figure 6), and where necessary it was chopped down to level (figure 5) and the walls were rammed directly onto this with a damp proof course deemed unnecessary. The rammed earth was reinforced with two rows of bitumen covered 12mm steel reinforcing rods with 90 degree bends below all openings as well as two rows of bitumen covered 12mm steel reinforcing rods at the top of the wall.

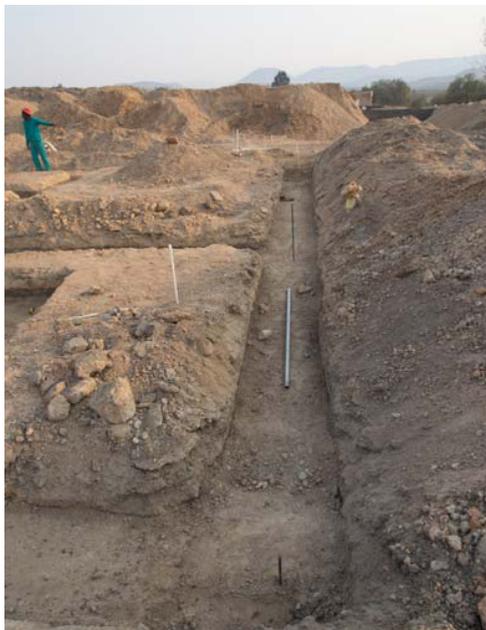
Figure 3 Completed Cement Stabilisation

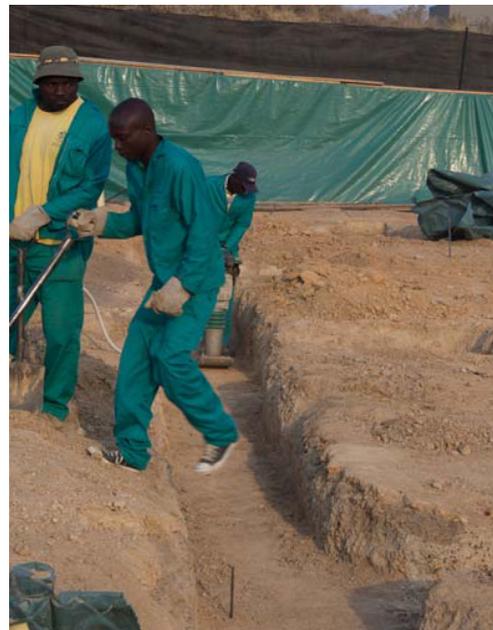
Figure 4 Compacting a polymer stabilised layer

The stabilised polymer was far more difficult to compact to level, it has the workability of sticky toffee and the presence of the services, sticking up vertically through the floor, prevented us using a large roller as recommended by the Ecobond supplier (figure 4) so a plate compactor was used. The floor was laid in 3m wide strips with gauge boards set up on both sides and a long straight edge used to level the material between them. The boards were levelled using 16mm diameter steel pegs, which provided a quick and easy method to set up a level to work from. Initial compaction was done with a rammer with the final compaction done with a plate compactor. A roller compactor had been recommended but as the distances between services were too small for it to pass, a plate compactor was used instead.

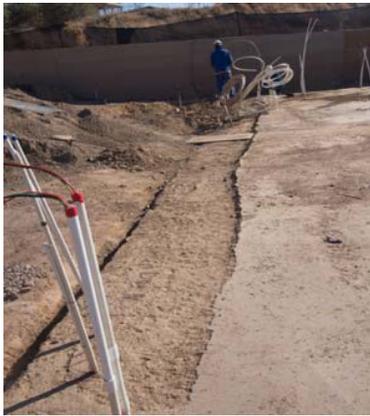
Figure 5 Polymer stabilised layer chopped down to level

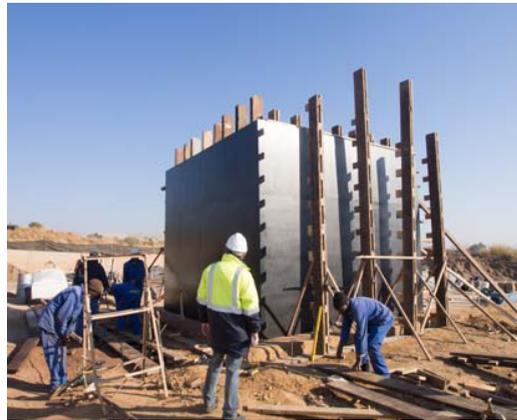
Figure 6 Erecting rammed earth formwork onto stabilised base

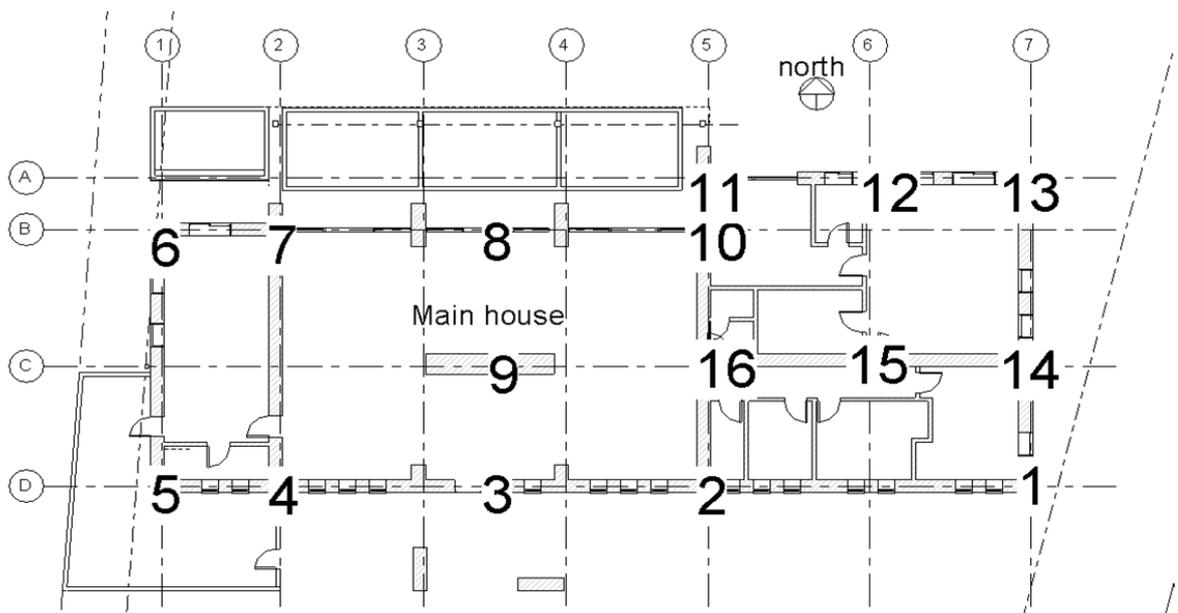
Figure 7 DCP test positions

Testing of the ground beneath the foundations, the cement stabilised earth and the PSE as well as the rammed earth was done with a dynamic cone penetrometer (DCP) at the positions numbered 1 to 16 (figure 7). A DCP consists of a 8kg mass dropping 575mm and knocking a 20mm diameter cone with a 60° point into the material being tested. The DCP measures the penetration rate per blow and from these results a California Bearing Ratio (CBR) is derived that gives an indication of in-situ strength. The CBR is an indirect measure of the soil strength based on its resistance to penetration. By comparing a large number of laboratory tests with field CBR values models have been developed to derive the unconfined compressive strength (UCS). A conversion that $UCS = 15 \times CBR^{0.88}$ has been derived [10] From the data collected graphs were plotted together with the CBR values (figure 8,9). Minimum CBR values had been determined by the engineer from the laboratory analysis and the loads the building was to withstand and DCP testing allowed immediate identification of any areas that were below the design specification

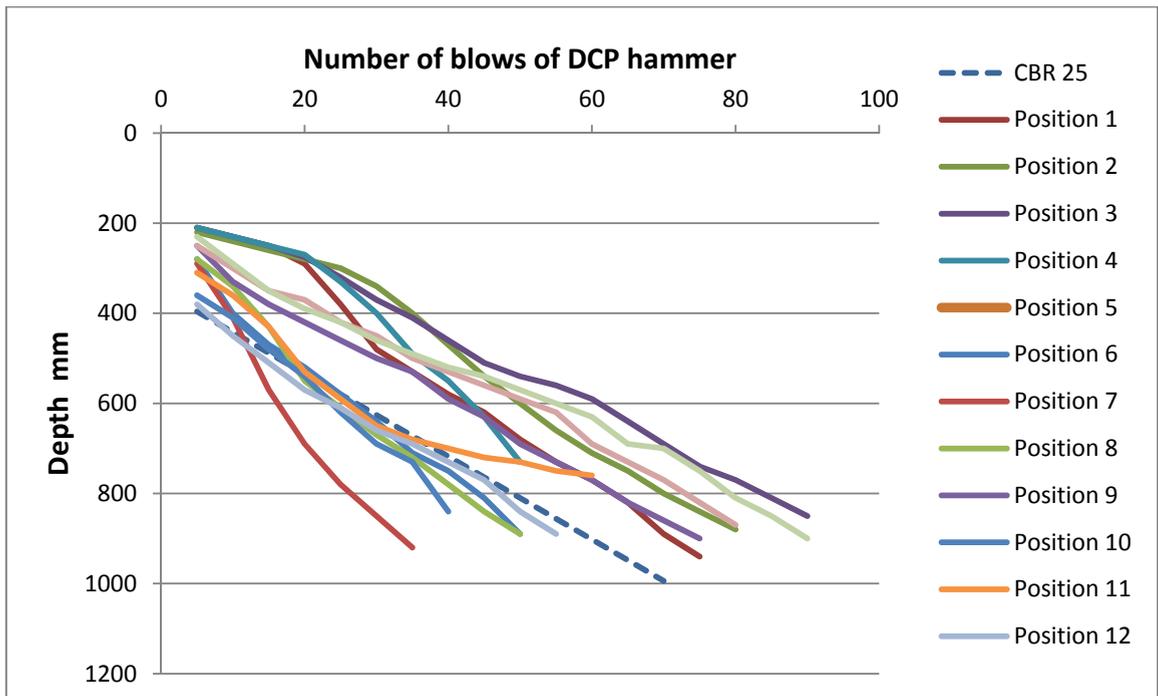
Figure 8: DCP plot of level below foundations 1500mm deep

of rain, the subsurface drains installed worked as designed removing most of the water. The polymer hardens and forms long chains through a dehydration process and this was significantly hampered by the surrounding wet ground (see position 7, (Figure 8)). Ecobond, the polymer used, gains strength when the polymer chains cross link and this occurs as it dries. The foundations were covered with plastic sheeting to prevent direct rain ingress, but the saturated surrounding soil had an impact on the rate the material gained strength. The ramming programme had to be adjusted to commence at the southeast corner as the northwest corner remained waterlogged for considerable time, but on drying the design strength was obtained.

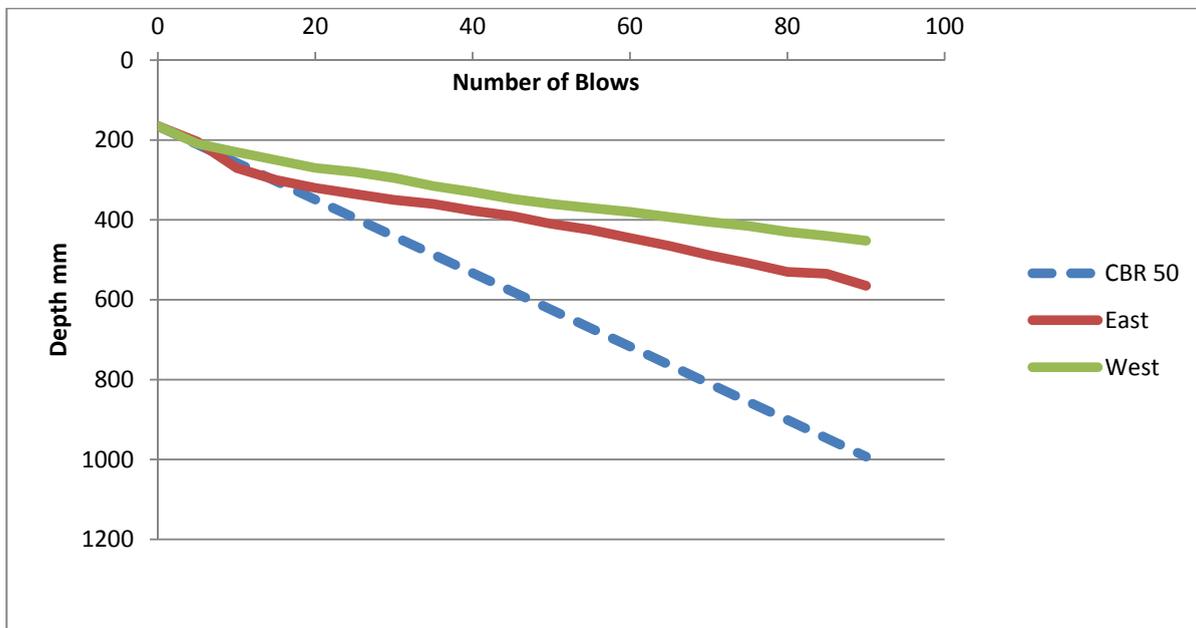
Figure 10: DCP results or rammed earth wall

Initial findings have shown that the foundation methodology is satisfactory with the rammed earth walls showing no signs of differential settlement. Ramming of the walls was done with pneumatic rammers in layers no more than 75mm thick and the DCP results were well above the design, as a result of prior layers receiving additional compaction from above, except at the very top of the wall (figure 10) where less compaction occurs. The only cracks found in the rammed earth are those below the window openings as a result of shrinkage (figure 10). These

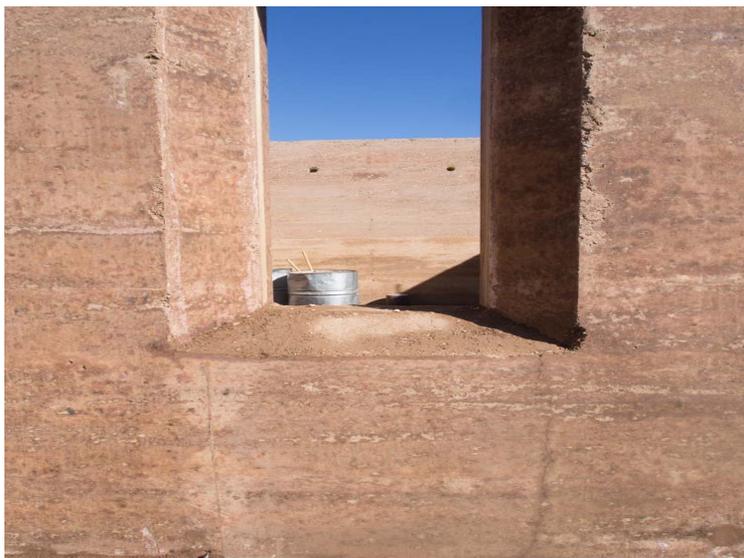
Figure 11 Shrinkage cracks

cracks were identified early in the construction process, and were eliminated by the placement of four 12mm diameter reinforcing rods, bent 90° at the ends, below each window.
